ELITE MOLD SERVICES

(407) 490-4272

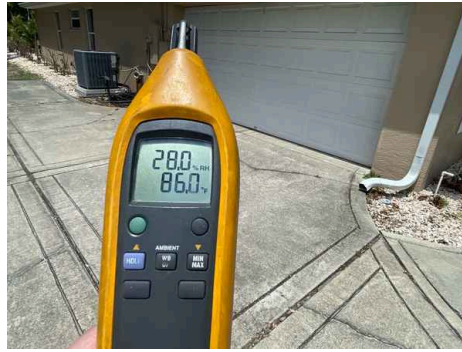
If yes, what kind of symptoms?

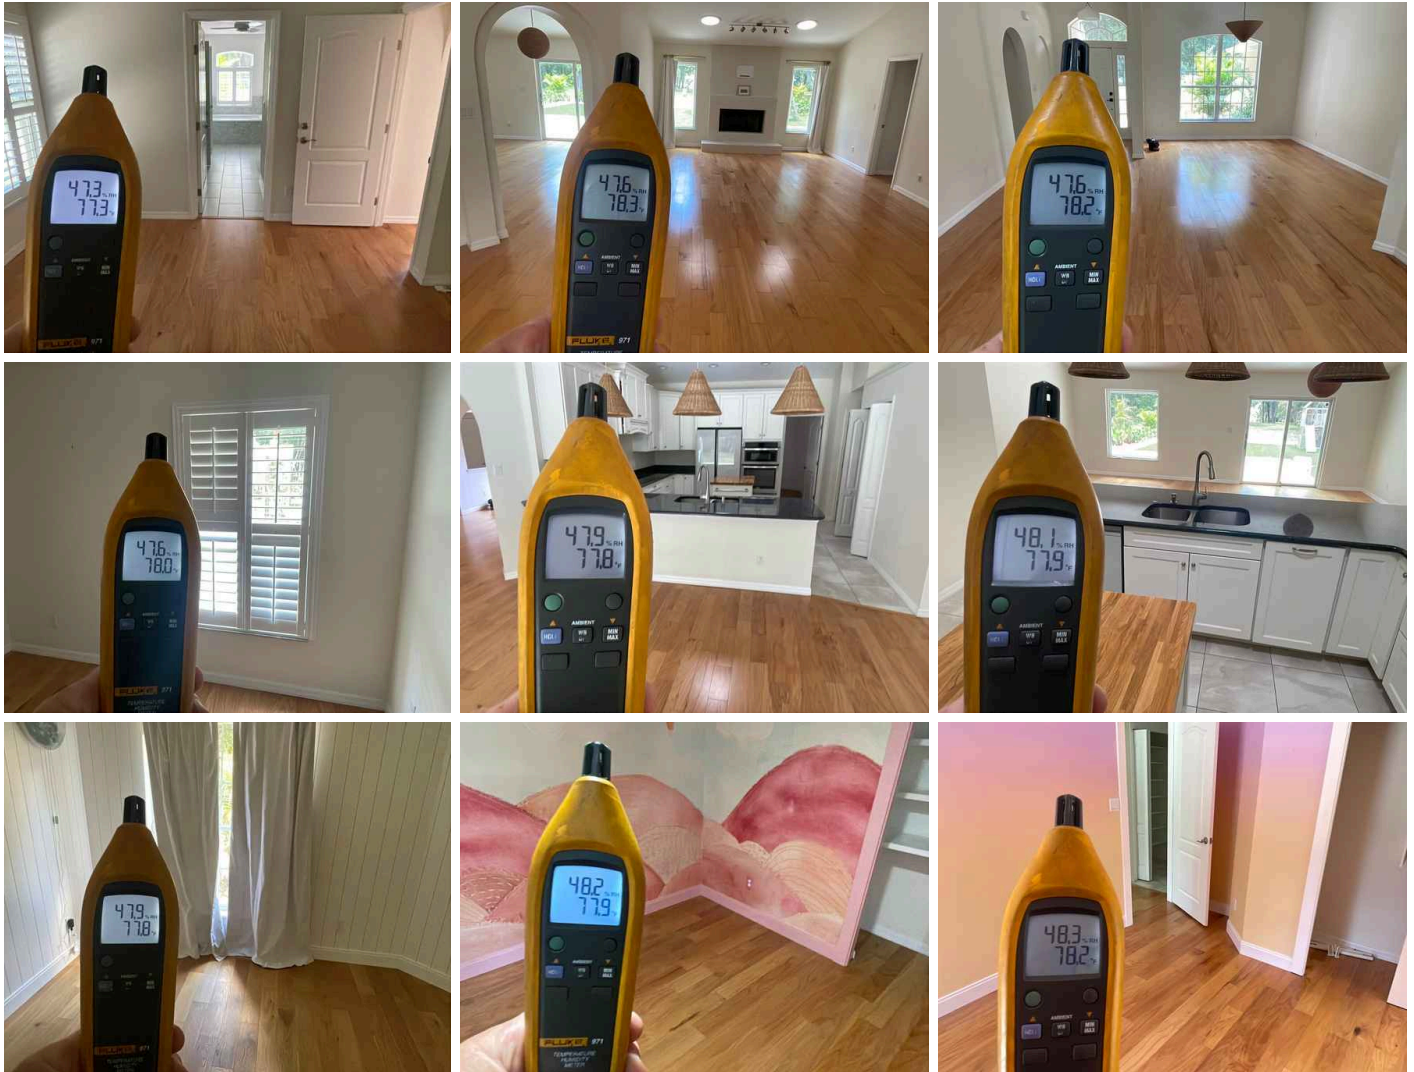
Are occupants experiencing any health-related issues?

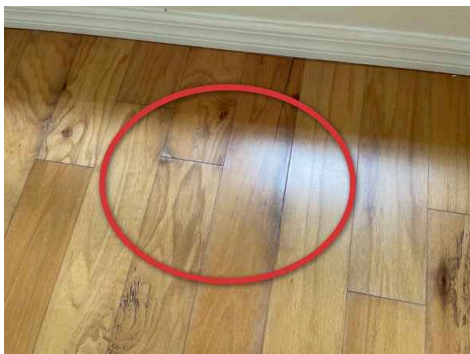
Possible water damage on floor below front dining room window

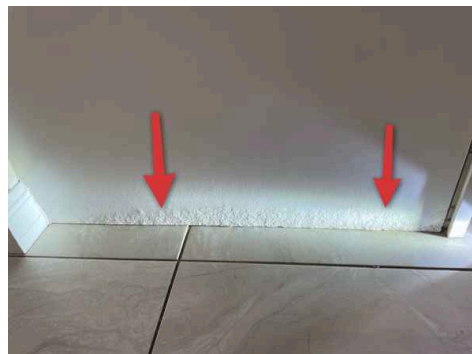
Water damage on end of kitchen cabinet, next to dishwasher

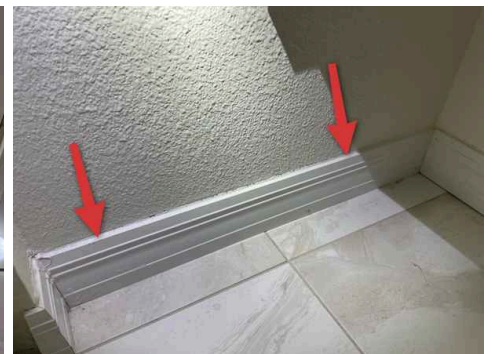
Baseboard separated from rear wall in left hall closet

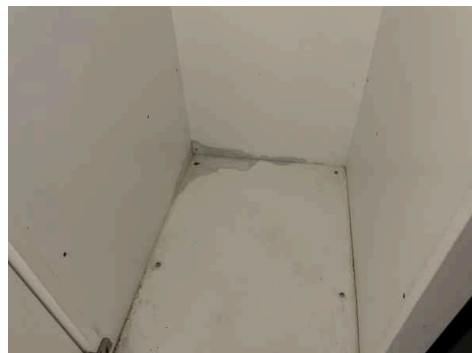
Stain inside laundry cabinet

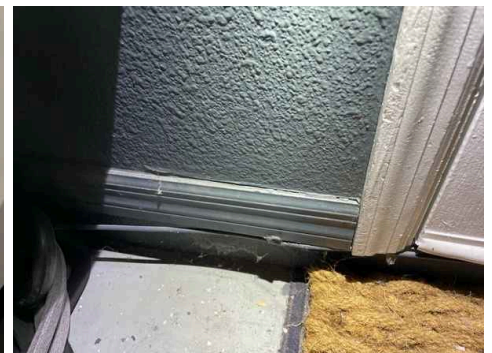
Baseboard separated from wall below garage sink

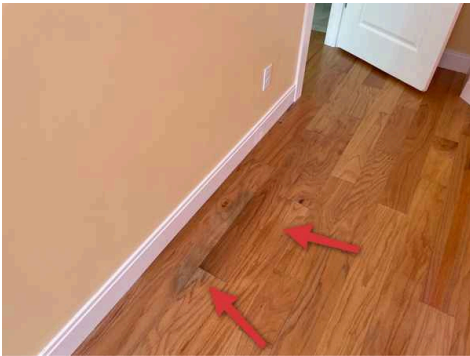
Possible water damage on flooring at right side of rear left bedroom

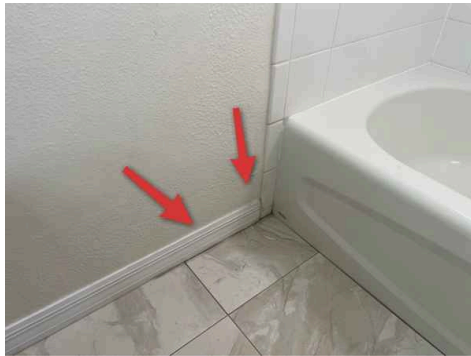
Baseboard separated from wall outside of left hall bath shower, across from toilet

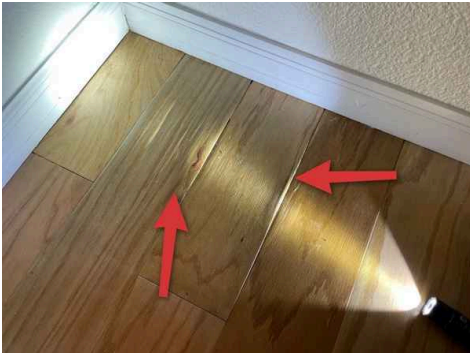
Water damaged flooring at front left bedroom closet, closet shares wall with air handler

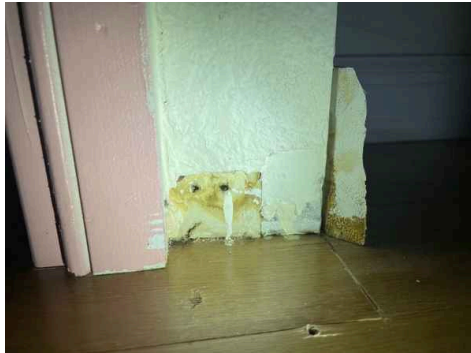
Staining on wall at right side of front left bedroom closet door, shared wall with air handler

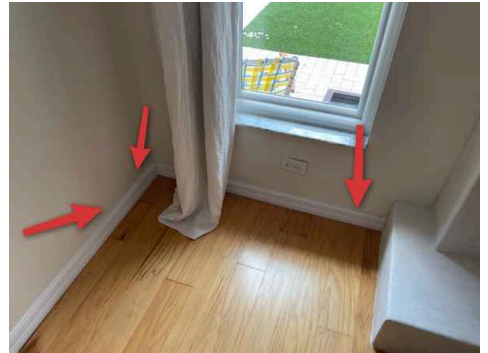
Baseboard separated from wall at rear left corner of living room

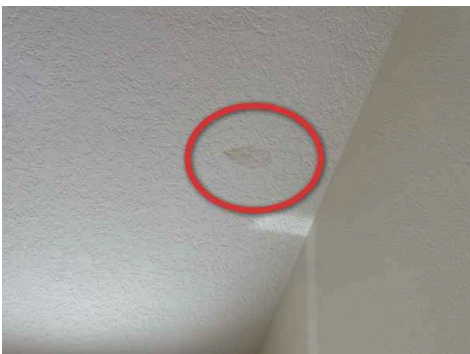
Stain on ceiling at rear right corner of living room

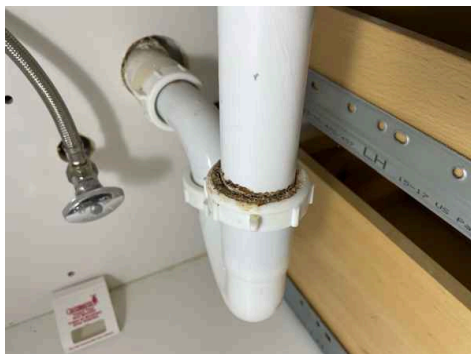
Corrosion on sink drain at right side of master bath

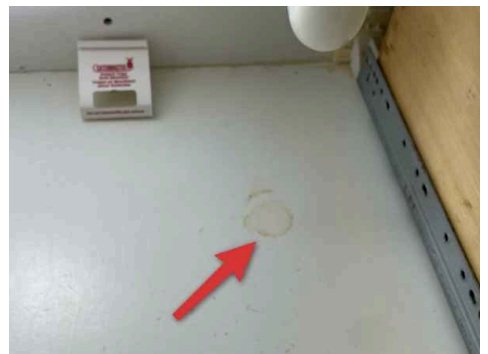
Stain on shelf below sink at right side of master bath

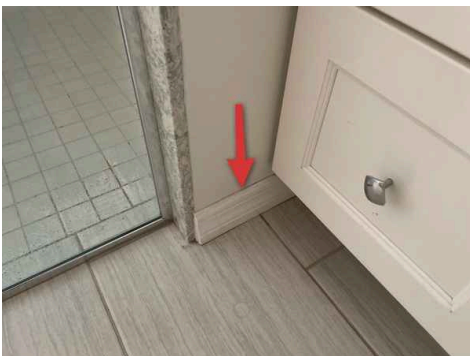
Baseboard separated from wall between master bath shower and vanity

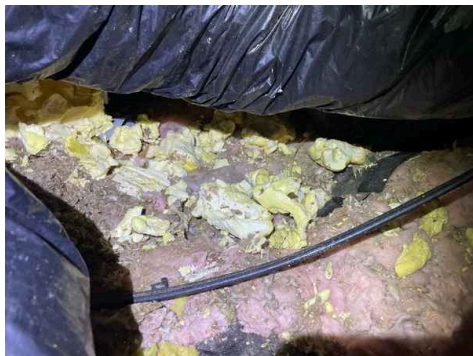
Insulation not removed from attic

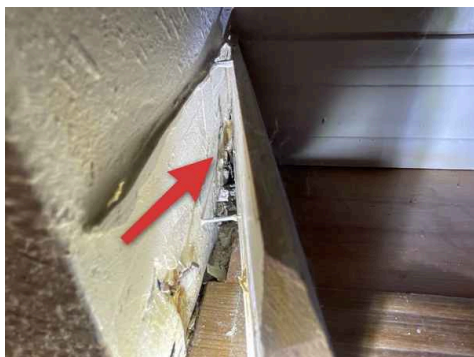
Behind baseboard at rear right side of front left bedroom closet, closet shares wall with air handler

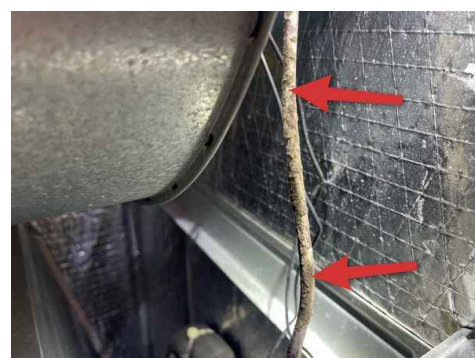
Growth on thermostat wire

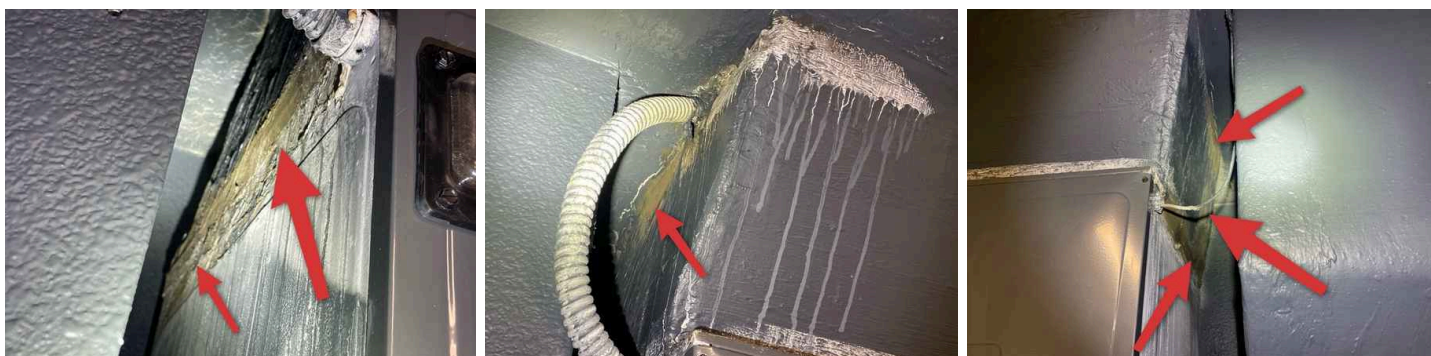
Contact a qualified HVAC professional.

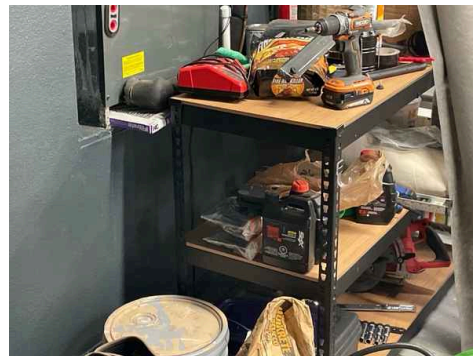
Shelf blocking filter removal

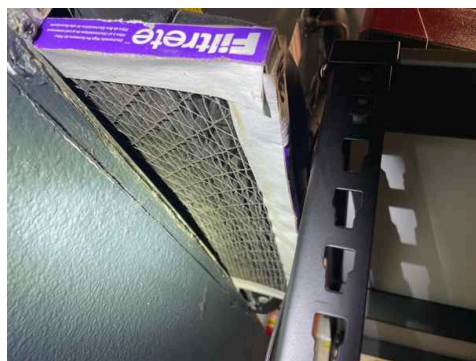
Contact a handyman or DIY project

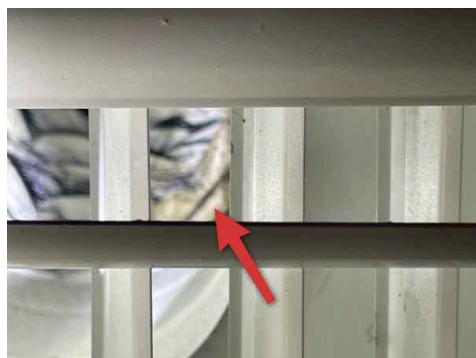
Contact a qualified HVAC professional.

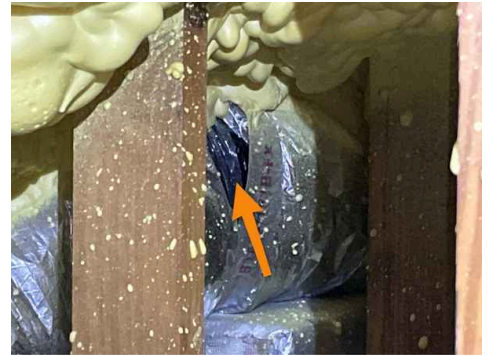
Right side of attic above air handler

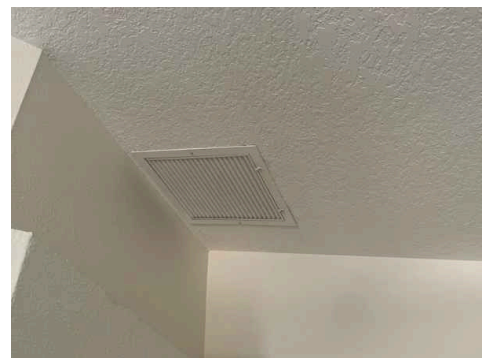
Contact a qualified professional.

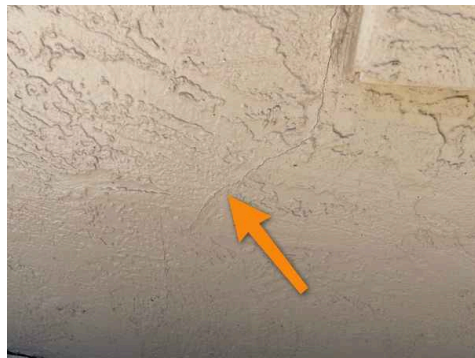
Below rear left window

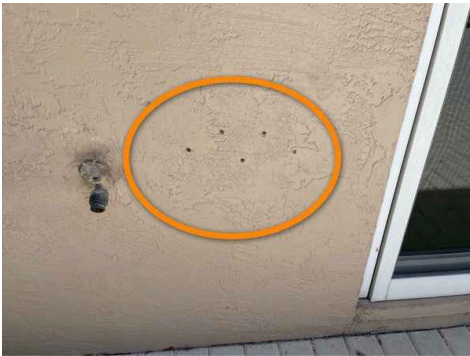
Rear side to right of sliding glass door

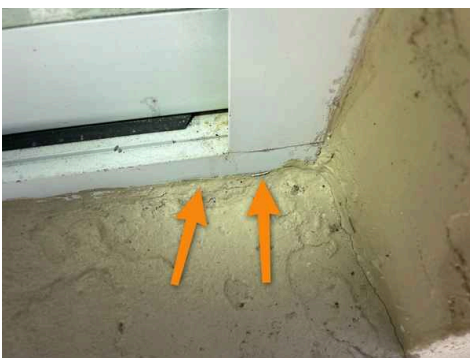
Contact a handyman or DIY project

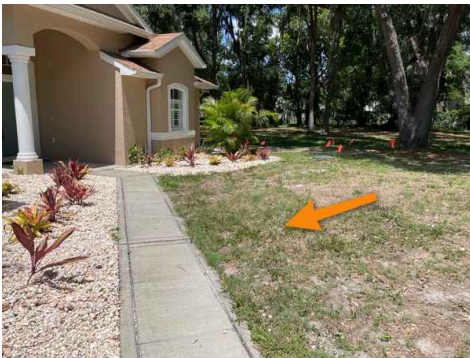
Contact a qualified landscaping contractor

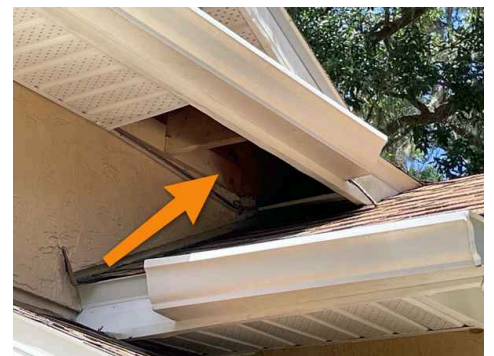
Missing it front right side

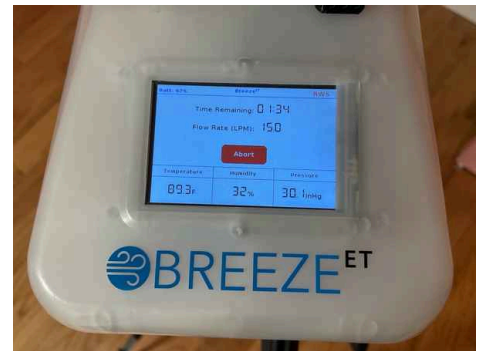
Sample Information: What type of samples were recommended?
